Dauerhafte Funktionsfähigkeit des Ventils A5244/0604/1012-F 24VDC in tiefkalter Umgebung soll geprüft werden.

Permanent operability of the valve A5244/0604/1012-F 24VDC in cryogenic environment shall be tested.

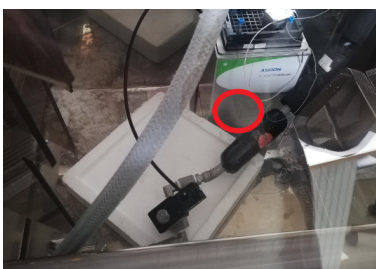
Abbildung 1: „Einbaulage“ im WB-Arbeitsraum; rot: externe Überwachung der realen Umgebungstemperatur (siehe exempl. Abb. 2)

Ventil befindet sich innerhalb des Arbeitsraumes  $T \sim -150^{\circ}\text{C}$  (siehe Abb.1).

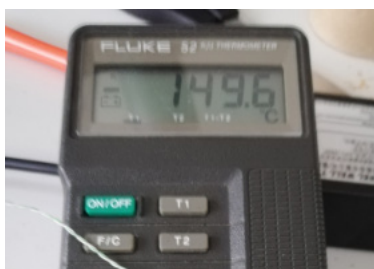
Abbildung 2: reale Umgebungsbedingungen des Ventils im WB-Arbeitsraum-Temperaturmessung

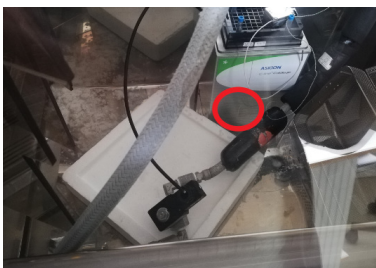
Fig. 1: „Installation position“ in the WB workspace; red: external monitoring of the real ambient temperature (see exempl. Fig. 2)

Valve is located inside the working chamber  $T \sim -150^{\circ}\text{C}$  (see Fig.1).

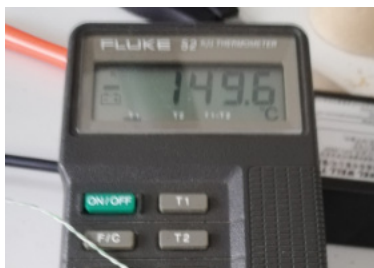
Fig. 2: Real ambient conditions of the valve in the WB workspace Temperature measurement
